Alan Scott

Physics Department
University of Wisconsin-Stout
Wisconsin's Polytechnic University

Fatal Friction Flaw

Simplified Model for An Introductory Physics Case Study

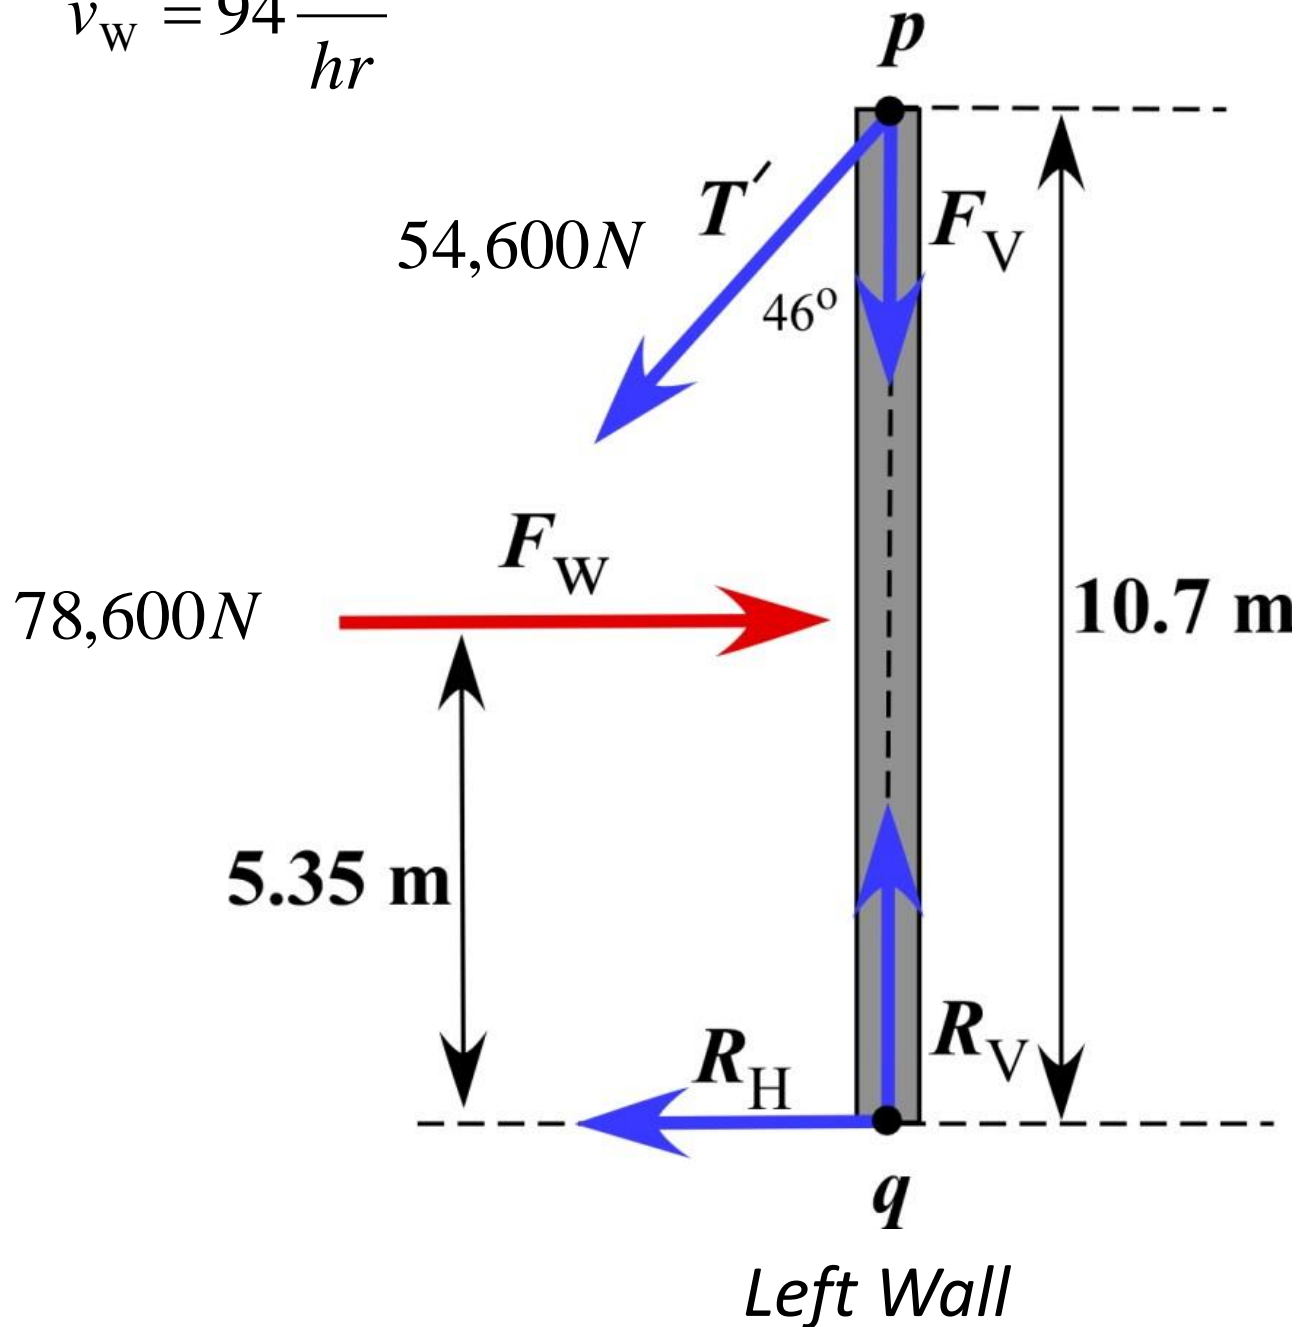
$$(F_{fr})_{\max} = 5,560N \quad T_x = 9,850N$$

$$(F_{fr})_{\max} < T_x$$

Triggered the collapsed and caused 7 deaths and 58 injuries!

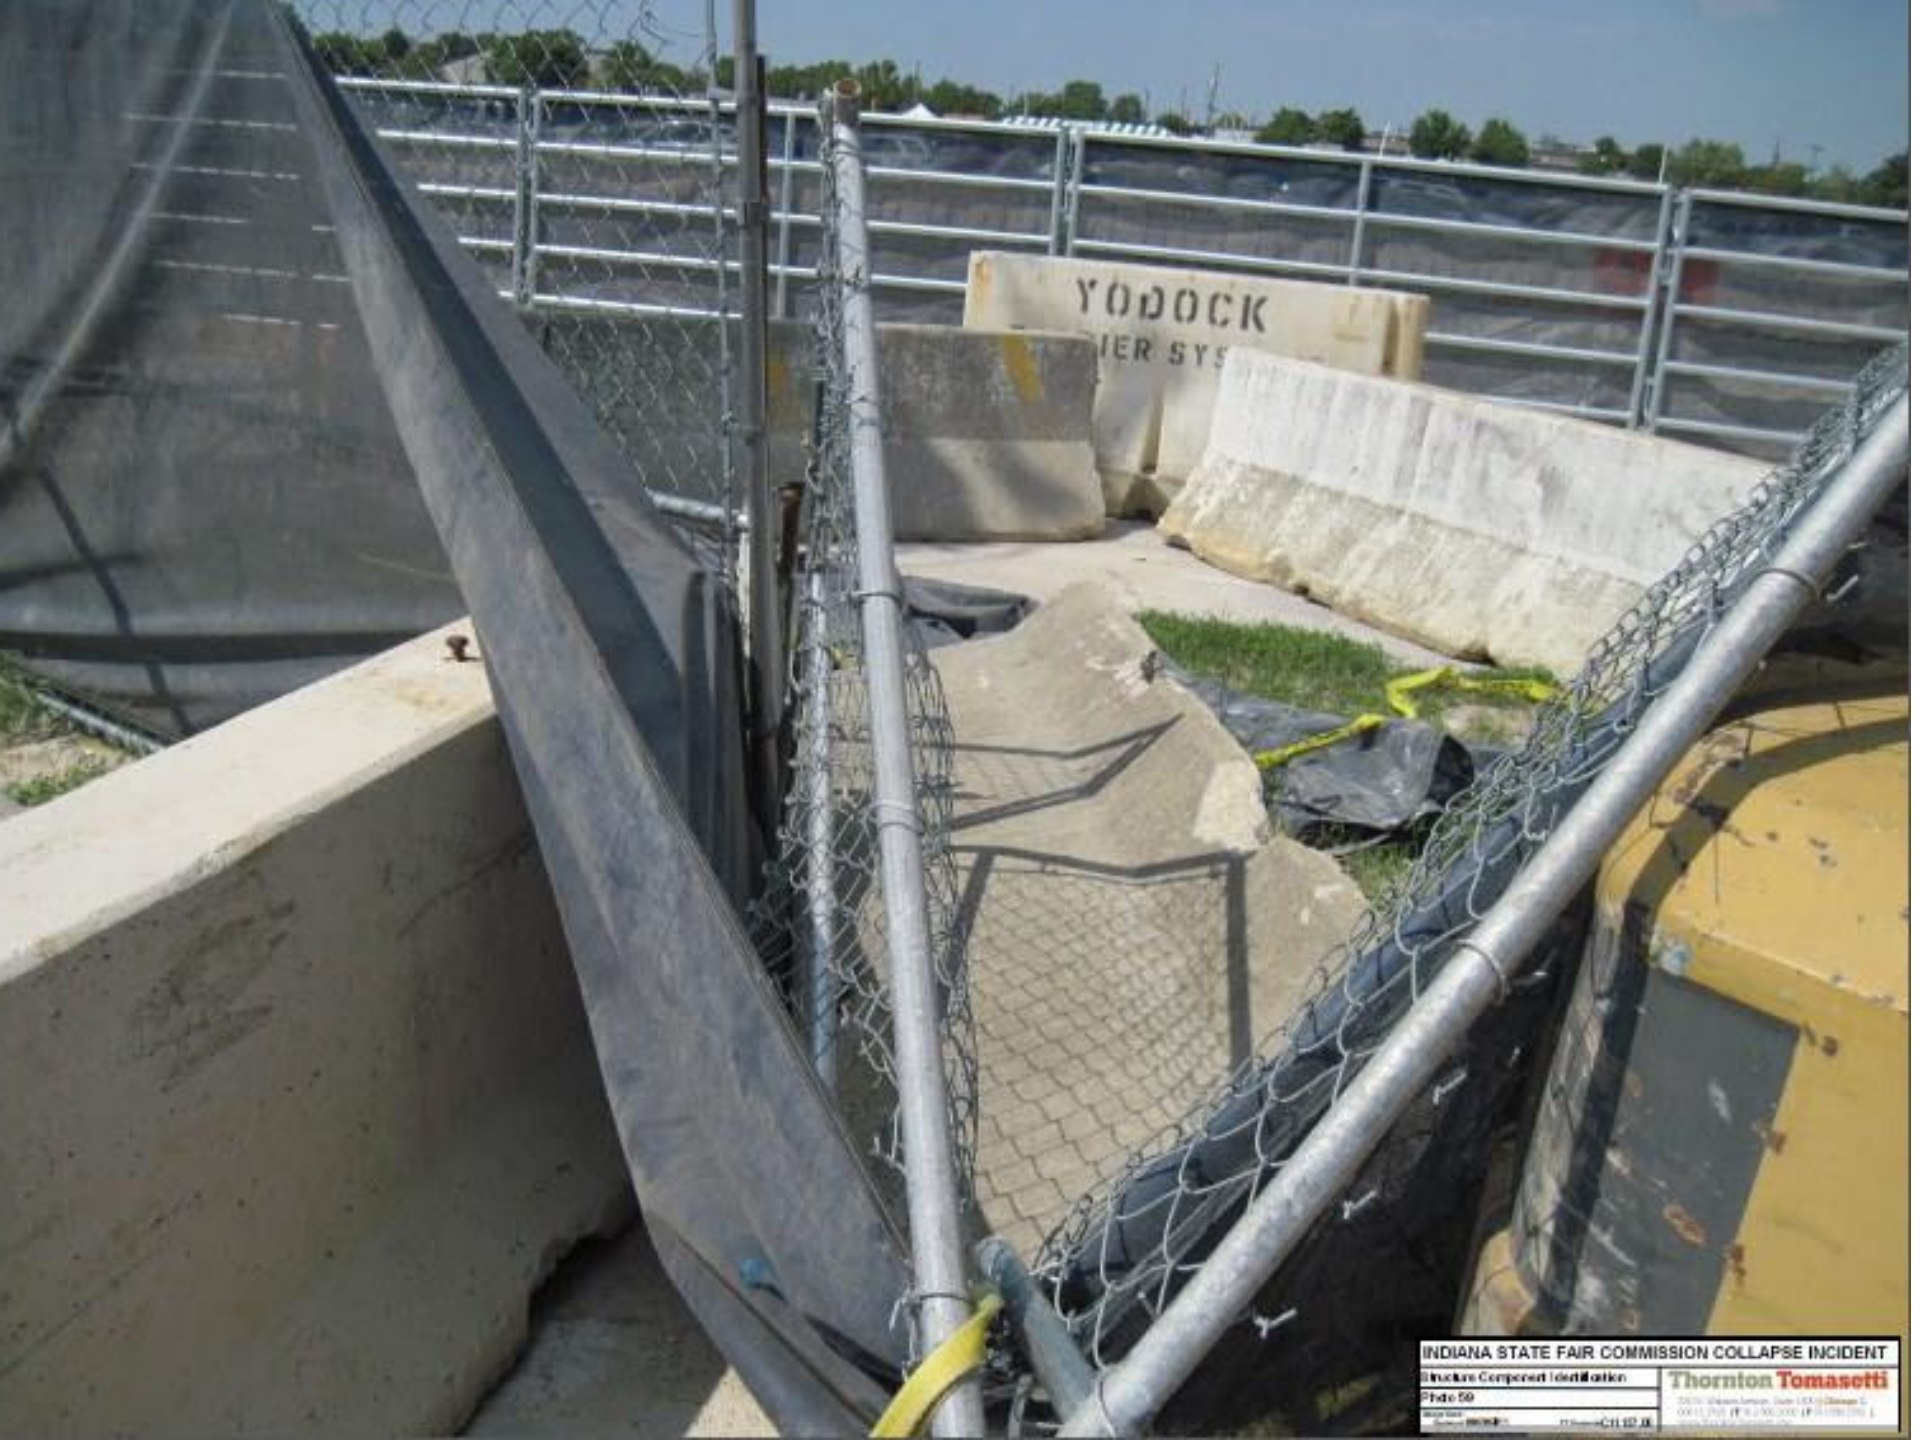
Photo 59

Structure Component Identification

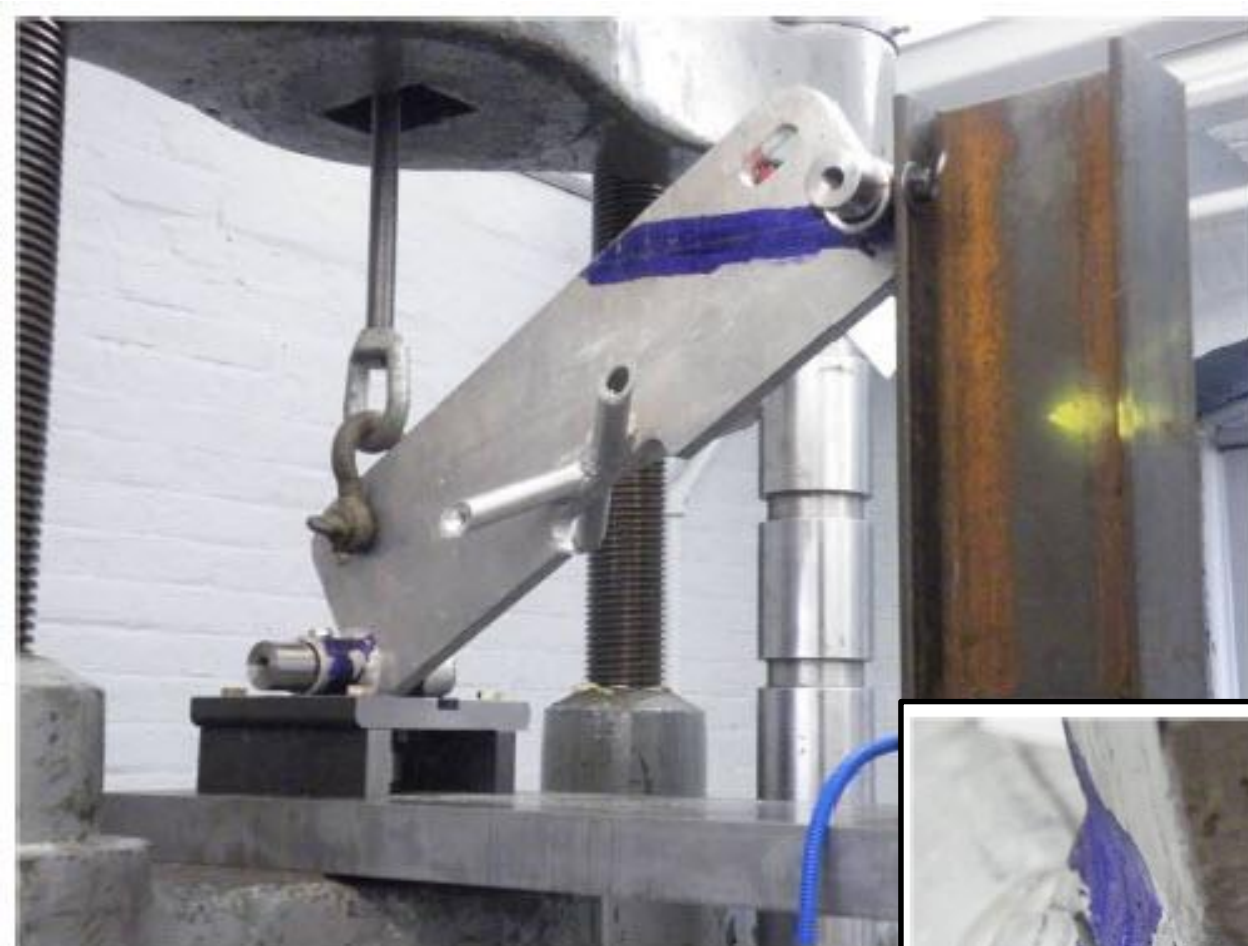
Fig. 6 Fin plate mechanical test setup

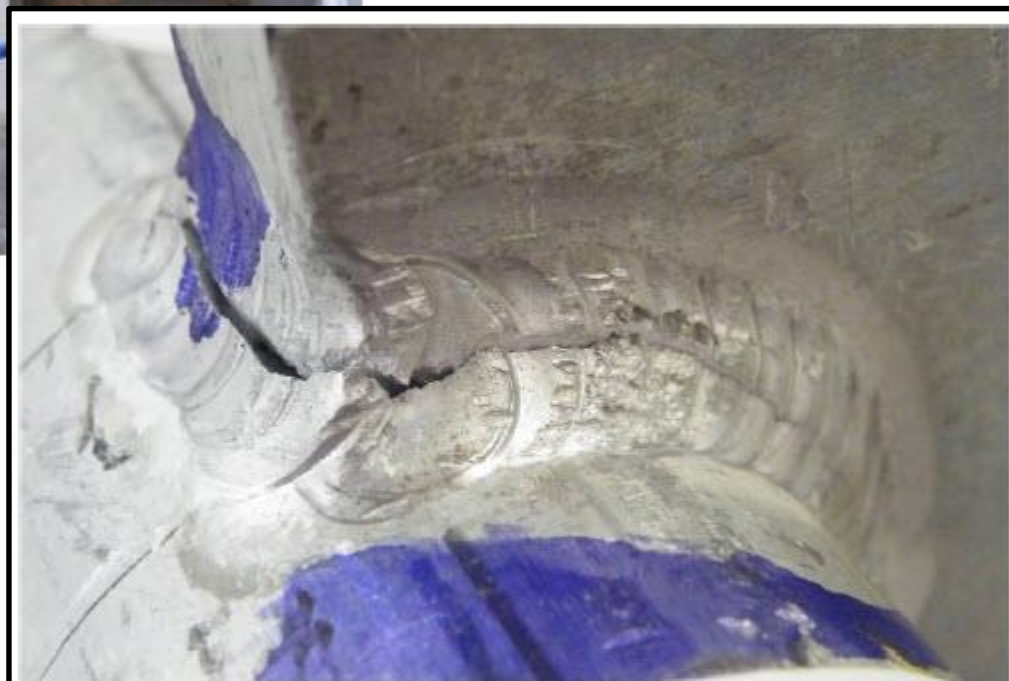
Fig. 8 Failure of fin plate F4 EAST

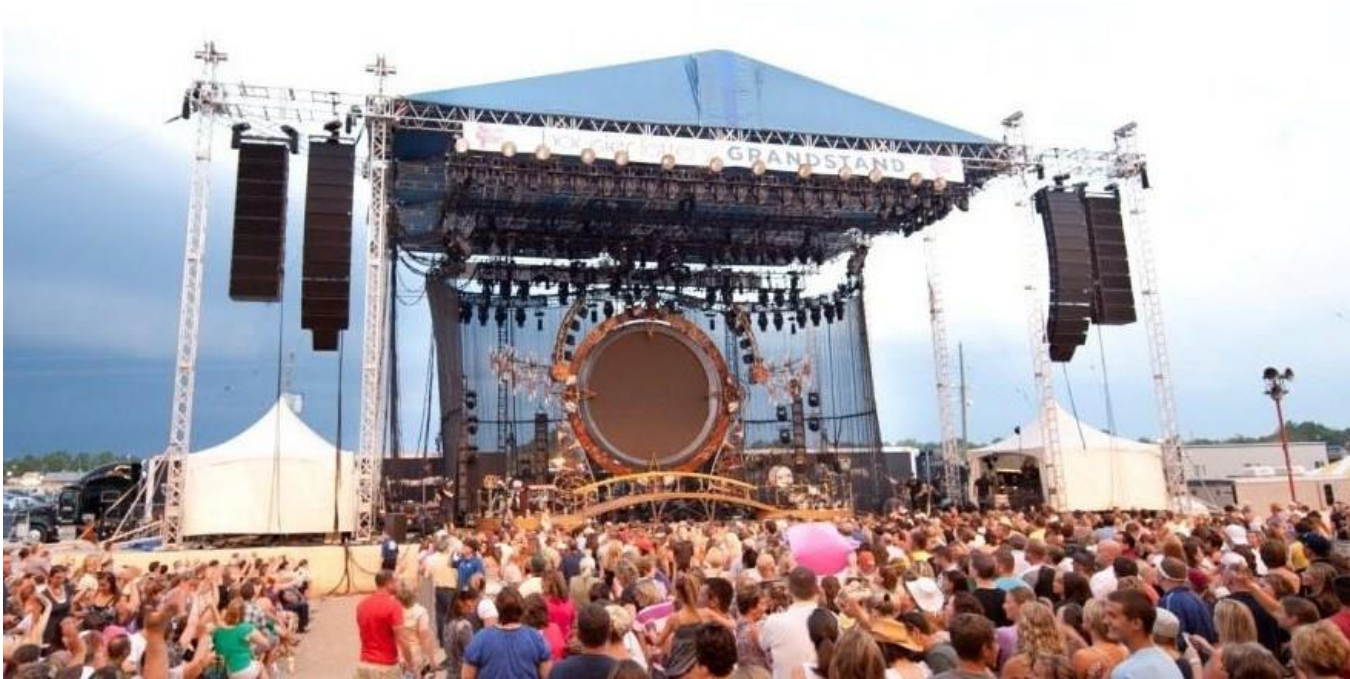
Key Findings

- Lateral Load
- Falls Short of Most Standards
- Straps, Ratchet, and Cables
- Fin Plates
